# Manhole Inspection Summary

Manhole # S21K\_\_017MH

Insp Date: **9/25/07 12:58 PM**

**Location** Address: **1822 DOVER-MCHENRY**

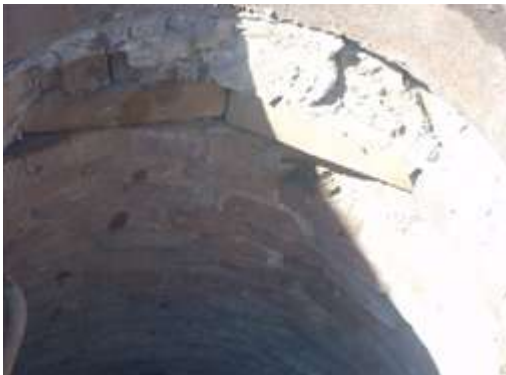
Defect 3

Condition: ☐ Sound ☐ Cracked ☐ Root Intrusion ☐ Loose Brick ☒ **Deteriorated**

CHIMNEY DETERIORION

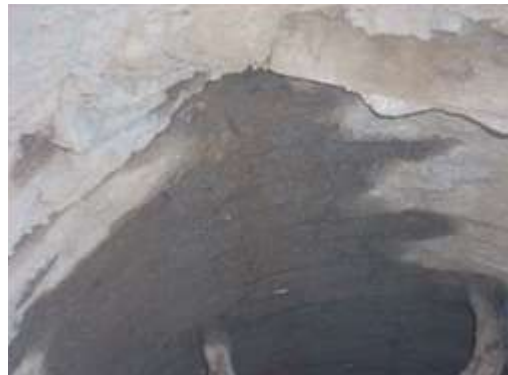
Defect 2

Infiltration: ☐ None ☐ Joint ☐ Cracks ☐ Mortar ☐ Roots ☒ **Wall**

CHIMNEY INFILTRATION

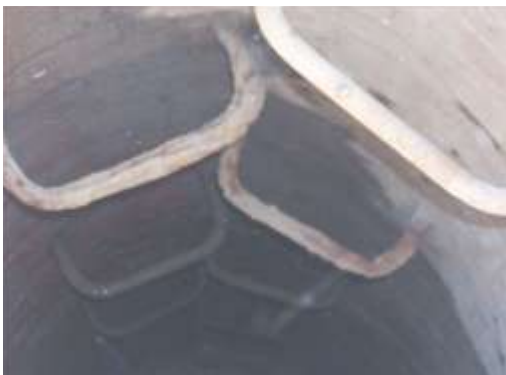
Defect 1

**Steps** Count: **9** Missing: **0** ☒ **Corroded**

CORRODED STEPS

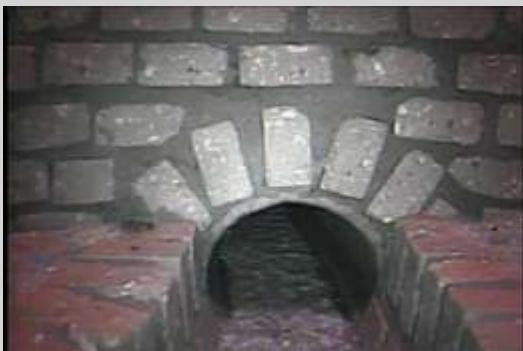
3 O'Clock Inflow

Pipe Height: **7.2** (in.) Rod and Bar (Angled)  
Pipe Material: **Clay** ☐ Pipe Lined  
Invert Depth: **13.89** (ft.) Flow Characteristics: **Slow**  
Deposits: ☐ None ☐ Mud ☐ Sludge ☒ **Debris** ☐ Grease  
Silt Depth: **2** (in.) Deposits Extent: **Light**  
Infiltration: **None** Pipe Seal Cond: **Sound**
